NASA
Technical Memorandum 105950

An Analysis of Gear Fault Detection Methods as Applied to Pitting Fatigue Failure Data

J.J. Zakrajsek and D.P. Townsend
Lewis Research Center
Cleveland, Ohio

Prepared for the
47th Mechanical Failure Prevention Group
Virginia Beach, Virginia, April 13-15, 1993

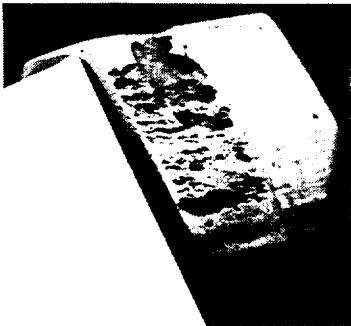
(b) Example of spalling on tooth in Run 1 at end of test ($t = 198$ hr).

Some examples of the different magnitudes of tooth damage found in the five tests (runs 1 to 5) of this study are illustrated in Figure 1. Figure 1(a) shows the isolated heavy pitting damage that was found on the test gears in run 1 at 131 hours into the test. Figure 1(b) shows an example of the spalling damage found at the end of the test of run 1. Figure 1(c) illustrates an example of the moderate pitting found in the tests. Similarly, Figure 1(d) gives an example of the heavy pitting damage found in the tests. Details of the damage found in each test are given below, with Figure 1 serving as a pictorial reference of damage magnitude.

advance of the RMS level increase. NA4 gave the best performance for run 1. Figure 2(f) shows the first 135 hours of Figure 2(d), with an expanded vertical scale, for clarity. As seen in these two figures, NA4 reacts very robustly to the start of damage, sharply increasing to a value of 25, and remains somewhat steady at a value of 15 even as the other parameters (FM4, M6A, etc.) drop back down to nominal values. NA4 then increases sharply to a peak value of 230, following a trend similar to the RMS level increase. This could be the point at which the extremely heavy damage started (as seen in Figure 1(b)), continuing to the end of the run.

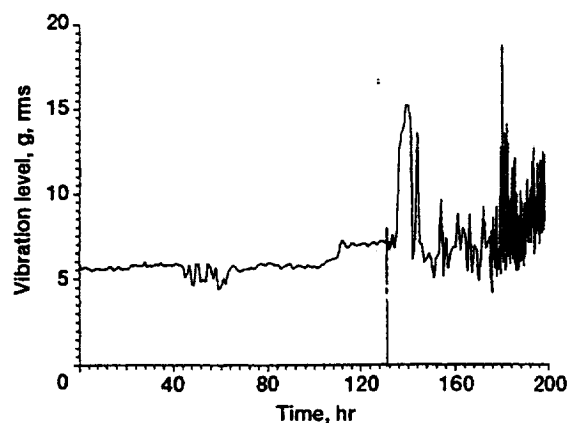
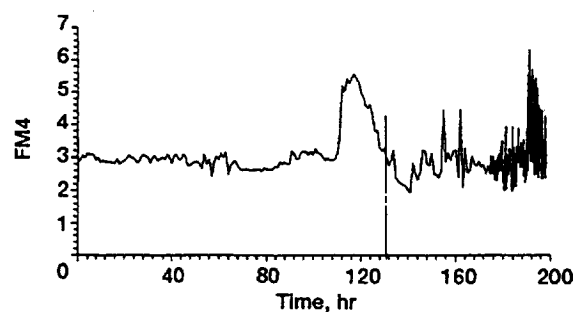
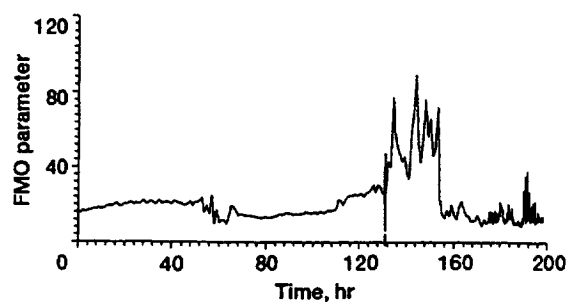
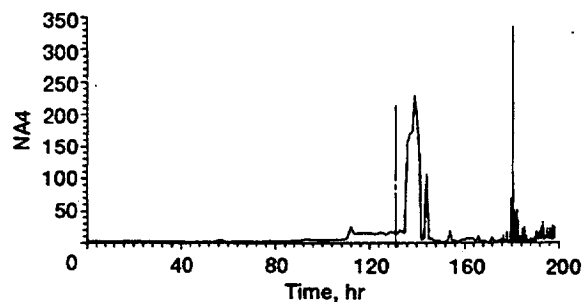
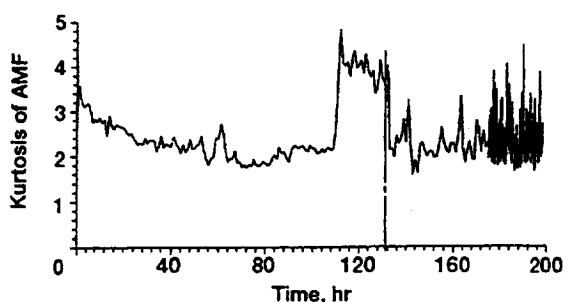
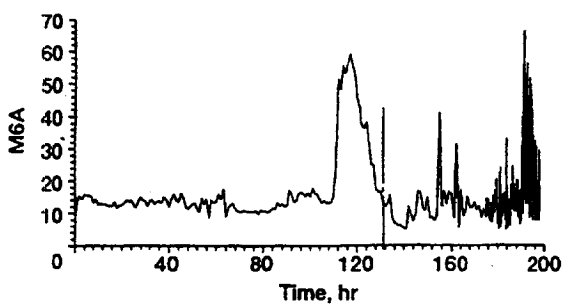
Figure 2.—Run 1 results.

Figure 2 presents the results of all the parameters for run 1. The vertical centerline in each plot represents the point in time ($t = 131$ hours) in which the rig was stopped and the damage was recorded, as shown in Figure 1(a). As seen in Figure 2, the parameters FM4, NA4, Kurtosis of AMF, M6A, and M8A all detect tooth damage at $t = 110$ hours, or 25 hours before FM0 reacts, and 27 hours before the overall root-mean-square (RMS) vibration level increases. FM4 peaked at a value of 5.4, then dropped off to the nominal value of 3 at $t = 131$ hours. It is possible that only one of the two teeth found damaged at $t = 131$ hours actually started at the time FM4 reacted, and when the damage spread to the other tooth, FM4 lost its sensitivity by decreasing back to its nominal value. The results of the demodulation method for run 1 (Figure 2(e)), are the best results obtained from that method. In other runs it showed results very similar to FM4 results (runs 2 and 3), or gave no indication at all (runs 4 and 5). As seen in Figure 2, M6A and M8A results follow the same trends indicated by FM4. M6A and M8A, however reacted more strongly to the damage, as indicated by the 300 percent and 863 percent increases over nominal values for M6A and M8A, respectively, as compared to an 80 percent increase for FM4. These results for M6A and M8A are very typical of the results obtained for M6A and M8A on the other four runs. FM0 gave a solid indication of over three times its nominal value, and 2 hours in

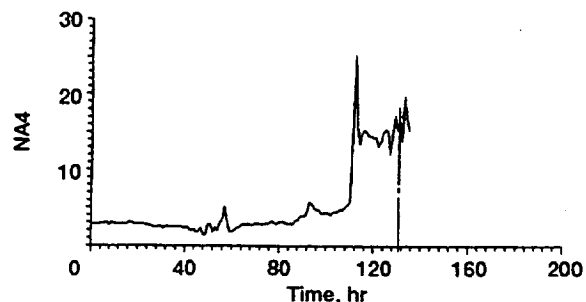
(f) NA4 up to $t = 135$ hr..

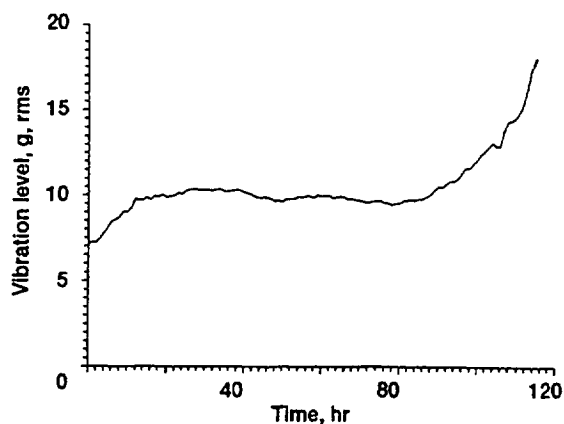
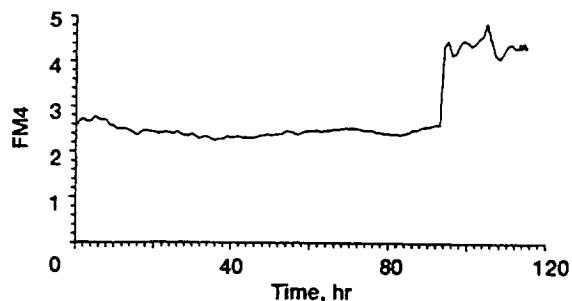
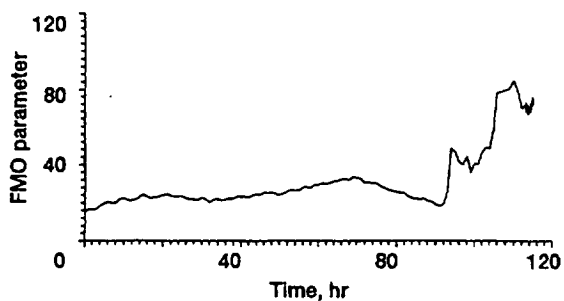
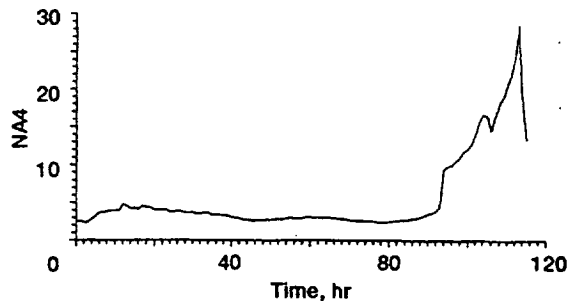
Figure 3.—Run 2 results.

As seen in Figure 3, the parameters FM0, FM4, and NA4 all react sharply to the tooth damage at 94 hours into run 2. FM0 reacted robustly to the damage, increasing to over double its nominal value, whereas the overall RMS vibration level gradually increases with run time. FM4 also reacted by increasing from a value a little under the nominal 3 to a relatively steady value of 4.5 through to the end of the run. Because the heavy pitting damage was still isolated to only one of the three damaged teeth on the driver, FM4 was able to continue to react to the damage. NA4 gave the most robust reaction to the damage, increasing sharply from the nominal value of 3 to a value of 9 at $t = 94$ hours. NA4 then continues to increase from 9 to a peak of 29, growing gradually with the damage until 2 hours before the end where NA4 then drops off, due to a sharp increase in the denominator of NA4.

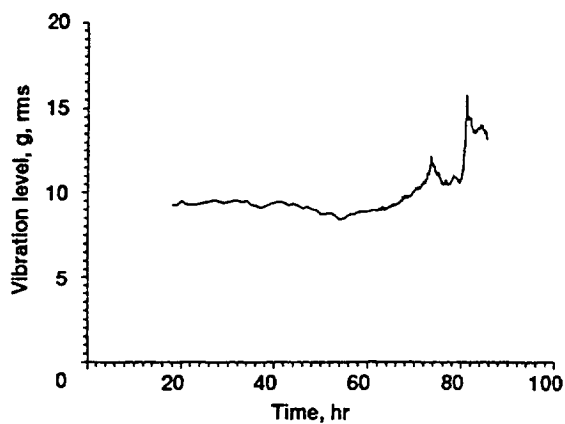
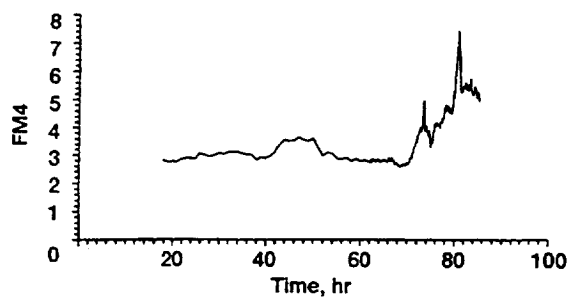
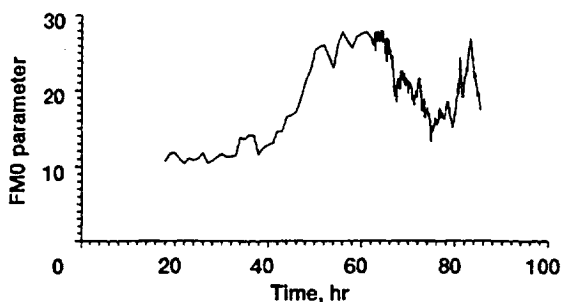
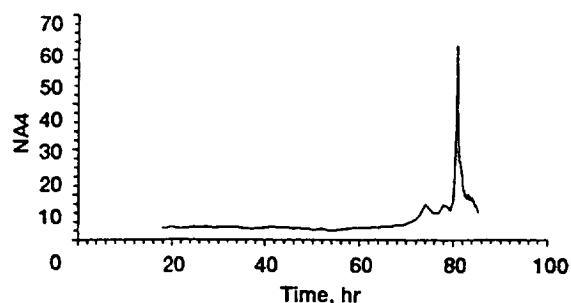
Figure 4.—Run 3 results.

In run 3, only FM0 showed any significant reaction to the start of damage at 43 hours into the run, as seen in Figure 4. FM0 increased to over double its nominal value at this time. The damage may have been too subtle for the overall RMS level to increase, and may have started somewhat simultaneously over the four driver teeth for FM4 to indicate only a low grade response at $t = 43$ hours. When FM4 and NA4 do react at $t = 74$ hours, possibly due to the spalling formation on one of the four driver teeth, NA4 again reacts more robustly, increasing to 8, as compared to 5 for FM4. Both parameters increase, but FM4 peaks at 7.5, whereas NA4 peaks at 43.

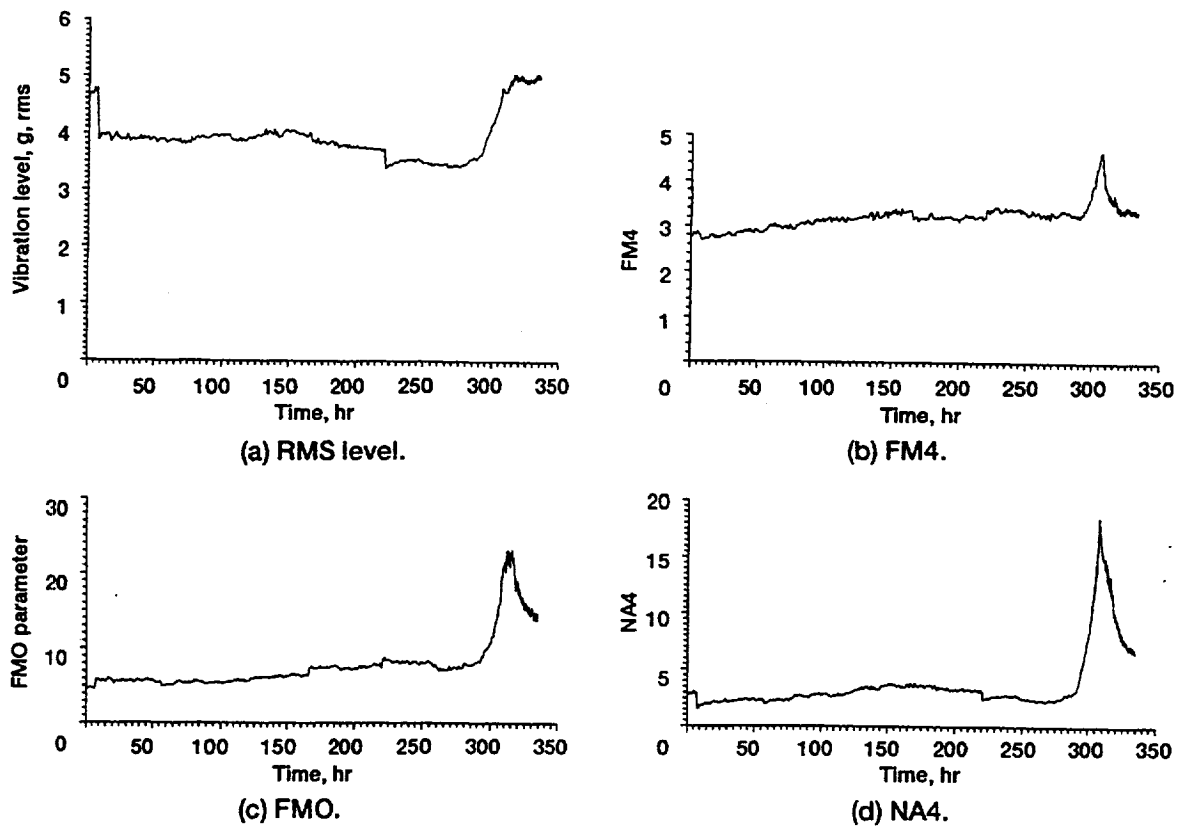
Figure 5.—Run 4 results.

As illustrated in Figure 5, the damage in run 4 was detected by FM0 and FM4 at the same time that the overall RMS vibration level increased. FM0 again shows a significant reaction to the damage, increasing in value to nearly three times its nominal value, as compared to the RMS level, which increases only 40 percent over its nominal value. FM4 peaks at 4.6, then proceeds to fall back to the nominal value. One of the two heavily damaged teeth on the driver gear may have started first, followed by heavy damage on the second tooth and the resulting decrease in the response and thus sensitivity of FM4. NA4 gives a strong indication of damage nearly 5 hours before the other parameters, and peaks at the value of 18.5, as compared to 4.6 for FM4. NA4 then decreases after the peak to 6.5, as its denominator increases, at the end of the run.

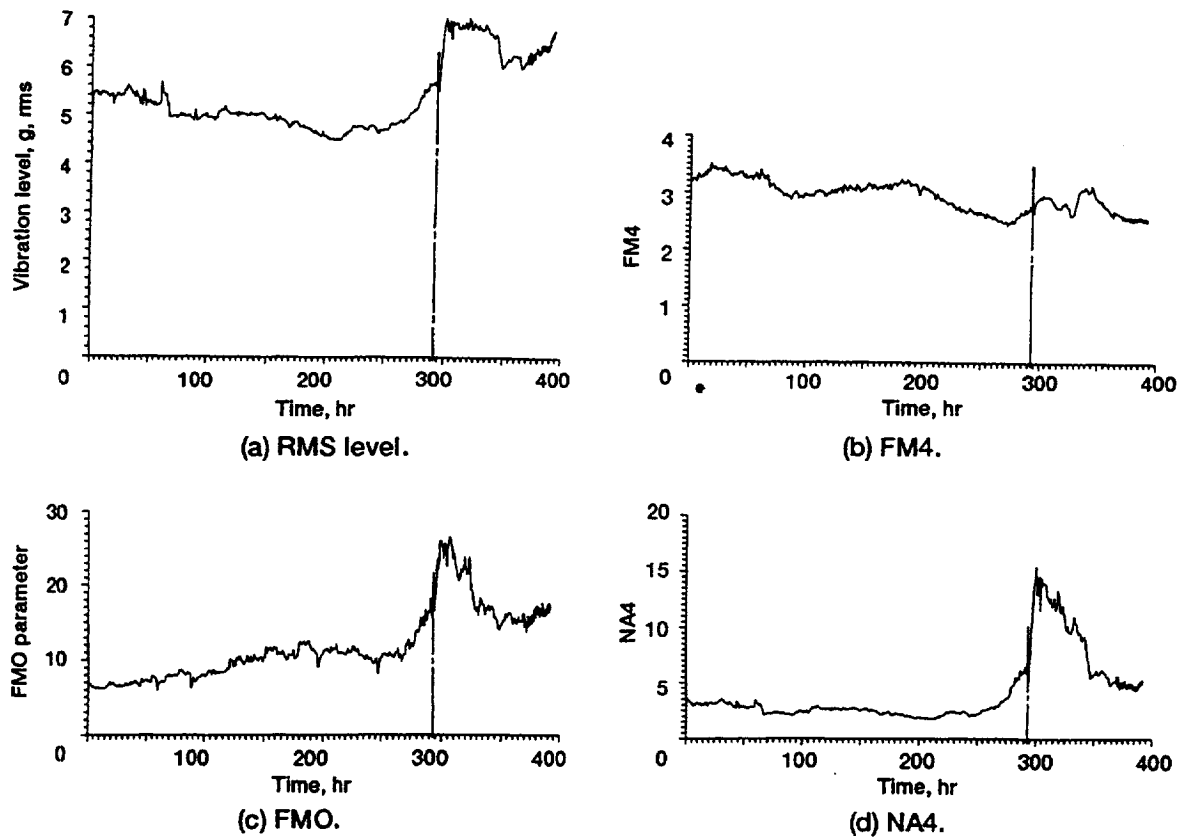
Figure 6.—Run 5 results.

The vertical centerline in all the plots in Figure 6 indicate the point in time ($t = 294$ hours) that run 5 was stopped and micropitting was found on nearly all the teeth on the driver gear. As seen in Figure 6, FM0 and NA4 clearly detect the micropitting damage. After this point, FM0 and NA4 increase sharply, with FM0 peaking at over twice its nominal value, and NA4 increasing to a value of 15, then slowly dropping off. The sharp increase seen in FM0, NA4, and even the overall RMS vibration level most probably corresponds to the initiation of the moderate pitting found on a number of teeth on both driver and driven gears at the end of the run. As evident in Figure 6(b), FM4 gave no indication of either the initial micropitting damage nor the moderate pitting damage found at the end of the run. Due to the nature of the damage, both the micropitting and moderate pitting damage may

have occurred simultaneously on more than one or two isolated teeth, FM4 was incapable of reacting to it.
